Maryland Inventory of Historic Properties Historic Bridge Inventory Maryland State Highway Administration Maryland Historical Trust

MHT Number_WA-II-1118

Name and SHA No. Sprecher Road over Marsh Run/W 5661 (W266110)

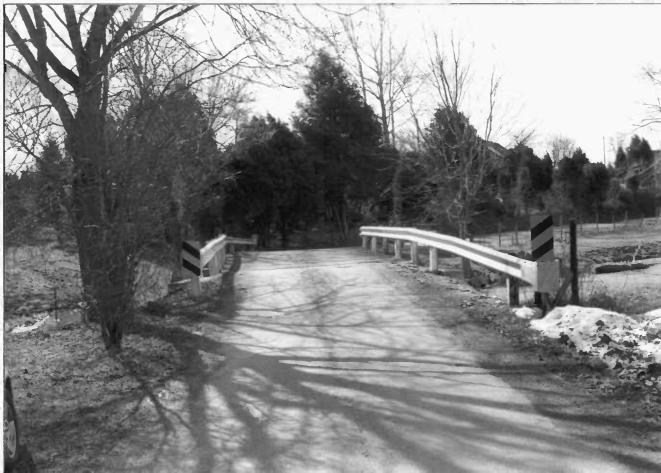
10F 4

DEST APPROACH

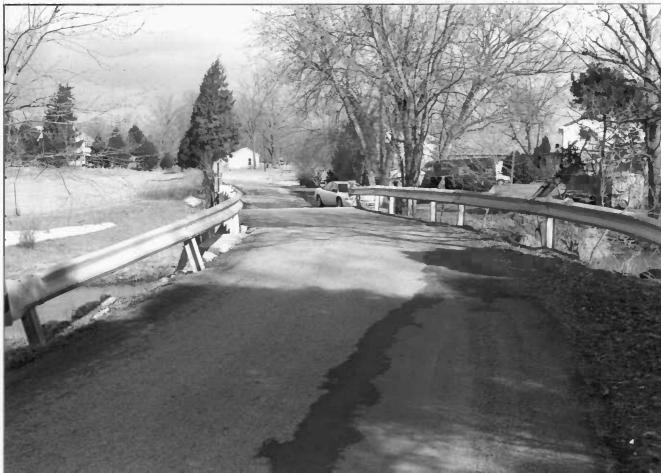
2 OF 4

EAST APPROACH

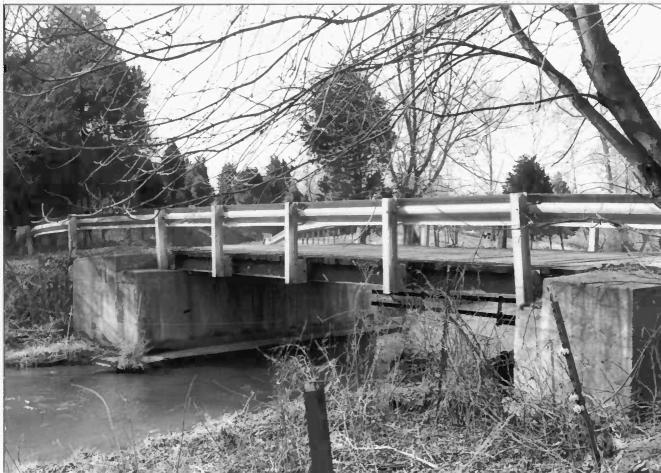
3 OF 4

SOUTH ELEVATION

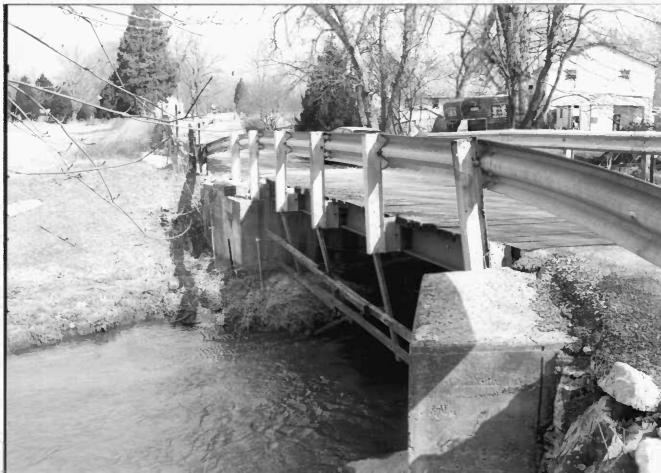
4 OF 4

NA II-1118 OVER MARSH RUN (15661) WASHINGTON CO. MD DAVID KING 2/24/95 S. H. A MORTH ELEXATION
